# Chapter 4

## Eelgrass & Cordgrass

#### 4.0 EELGRASS AND CORDGRASS PILOT RESTORATION PROGRAM

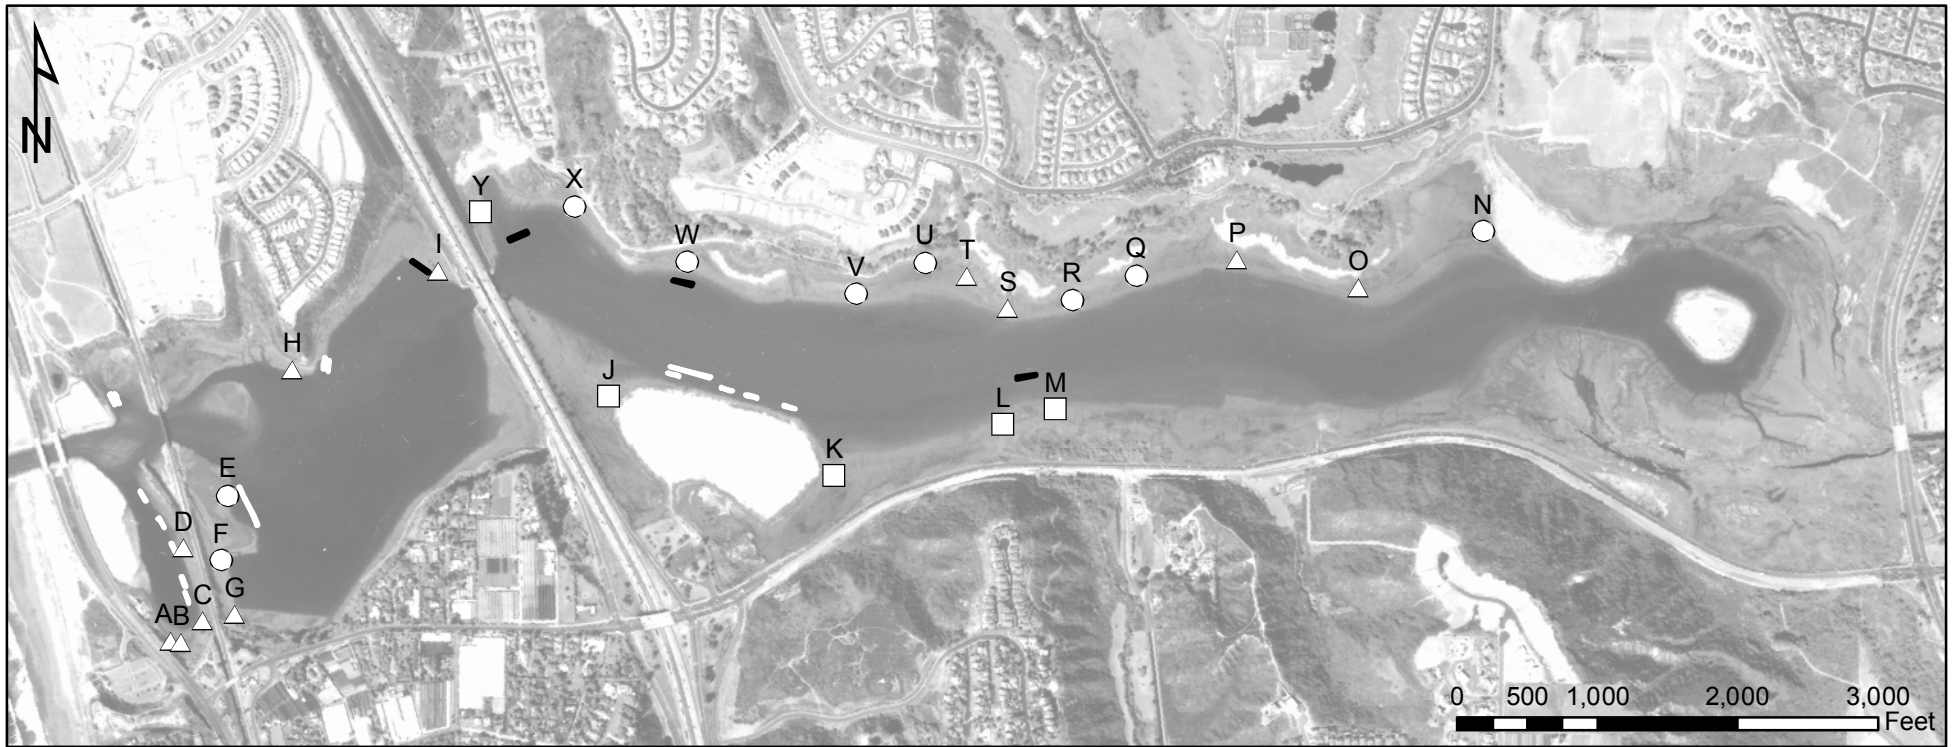
**Figure 4-1**

**Eelgrass and cordgrass pilot transplant locations**

After allowing additional time for further sediment stabilization within the lagoon, four additional transplant sites (each consisting of 150 planting units) were planted in the east and central basins on August 26, 1998 (Figure 4-1).

Cordgrass was transplanted on April 16 and 17, 1998 at 20 sites in the west, central, and east basins (Figure 4-1). The sites were selected to represent a range of tidal elevations and levels of exposure to wind and waves in order to determine the conditions most favorable to the establishment and expansion of cordgrass. Bare-root cordgrass was collected from the San Diego River Flood Control Channel. Cordgrass was transported to Batiquitos Lagoon in gardening flats covered with damp burlap. The cordgrass was planted as plugs, consisting of two to three cordgrass shoots, 3.3 feet apart along multiple rows perpendicular to the water line at each of the transplant sites. At the time of transplant, the sites were gently sloped, unvegetated mudflats and were established at elevations as low as approximately +2 feet Mean Lower Low Water (MLLW) and as high as +6 feet MLLW. In October 1998, a qualitative assessment of the 20 pilot sites was completed, and nine of the sites were chosen for expansion based on success of the original plantings. Five additional sites were also identified for planting. On October 20, 1998, a second transplant was completed at these five sites. A total of 16,000 ft<sup>2</sup> (0.38 acre) of cordgrass was planted within the lagoon during the two transplant phases.

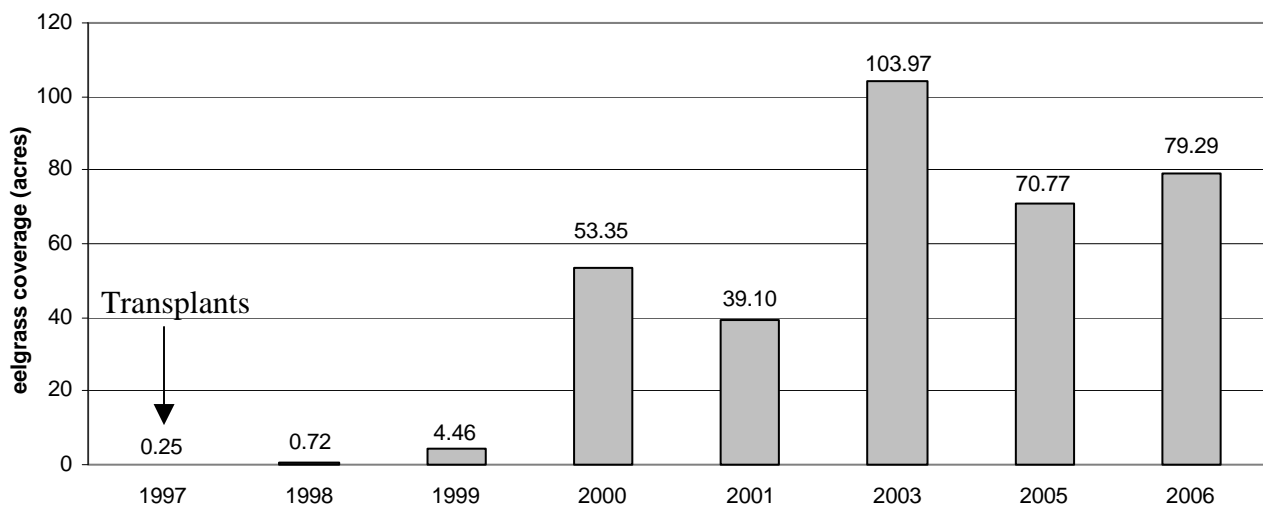
Figure 4-2. Eelgrass coverage (1997-2006).

In October 1997, 0.25 acre of transplanted eelgrass was present in the lagoon (Figure 4-2). By October 1998, 70 to 80 small patches, each approximately 100 ft<sup>2</sup> in size, had recruited into the central basin (Figure 4-3a). Based on the distribution in the southern region of the basin, it appeared that this eelgrass recruited from seed transported from materials planted in the west and central basins. The west and east basins showed a more modest expansion but with obvious growth of new patches. By 1999, eelgrass had expanded to 4.46 acres and was still most abundant in the central basin, where the small patches had expanded clonally to form rings 15 to 30 feet in diameter. In 2000, the smaller patches that had formed during the previous two years grew rapidly, forming relatively continuous beds in all three basins (Figure 4-3b). The west and central basins had reached near maximal levels of eelgrass cover and fluctuated in cover from that point onward (Figure 4-2, Figures 4-3b and c). In the east basin, eelgrass cover continued to expand eastward until 2003 and then fluctuated in cover over the next two sampling intervals.

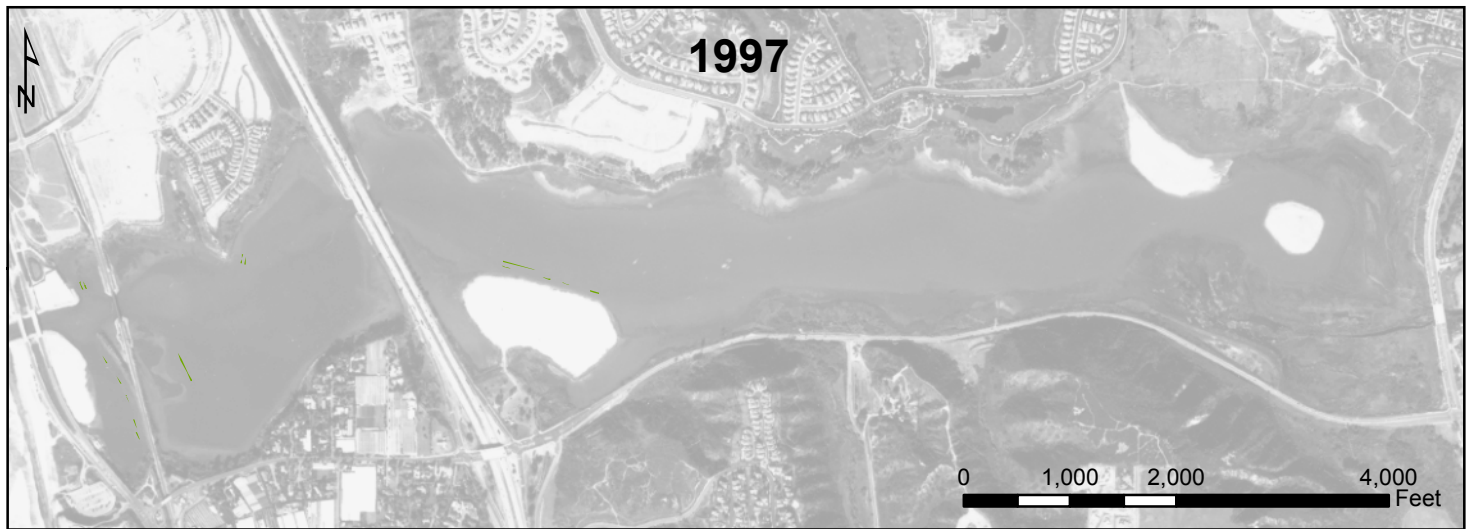
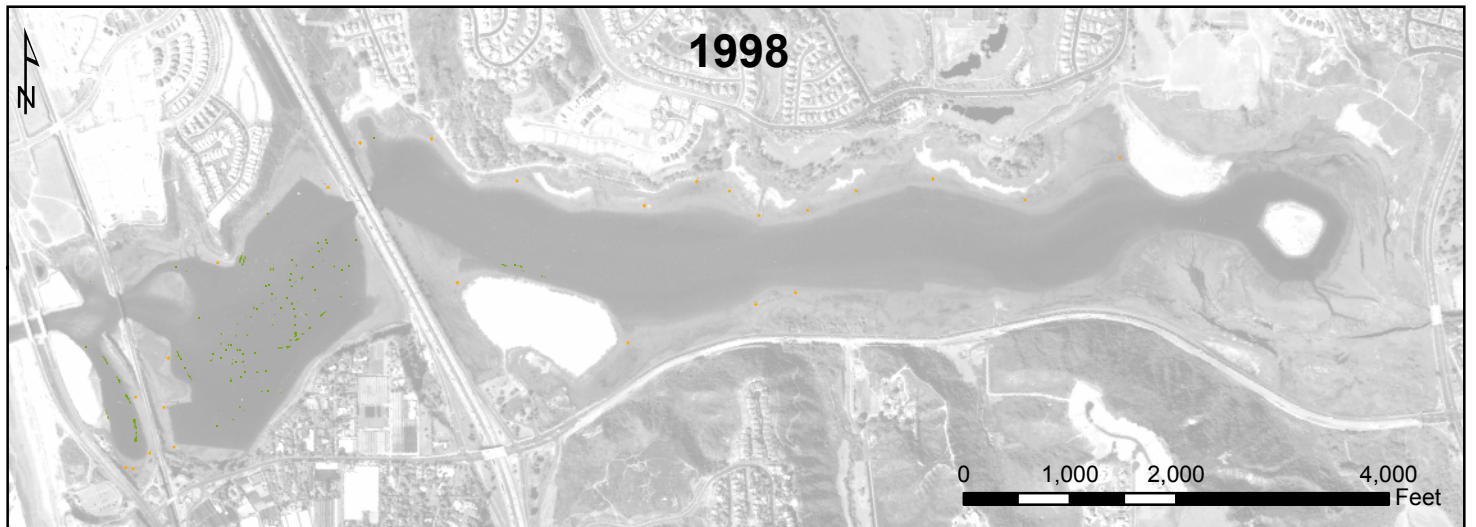
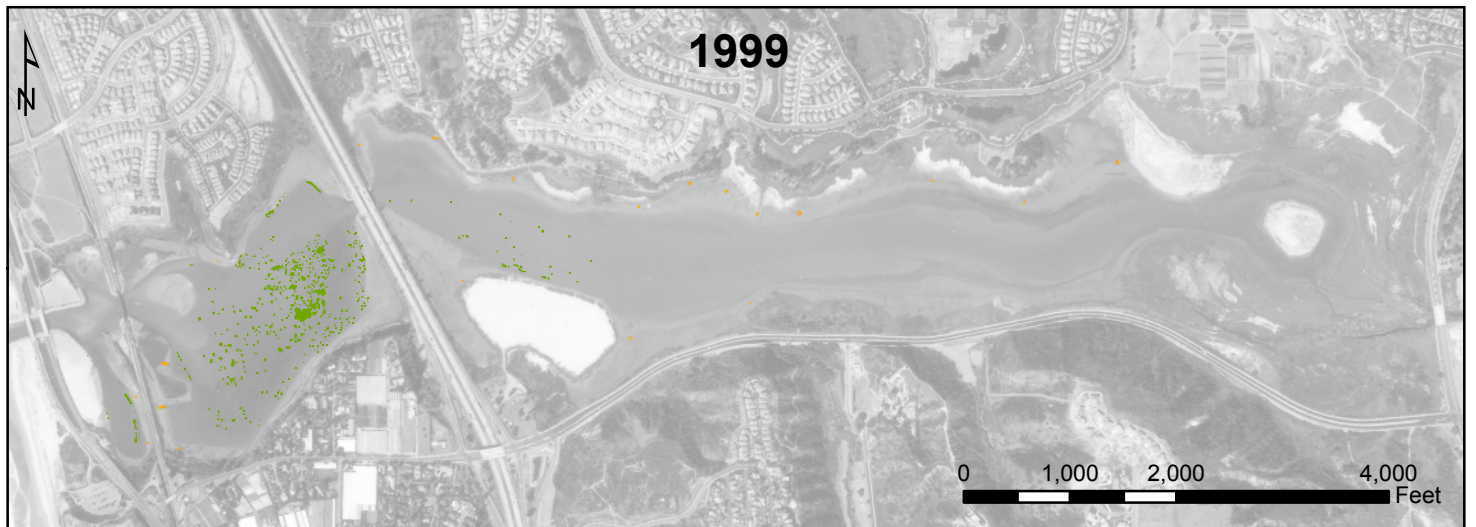
**Figure 4-3a**

**Pilot revegetation program  
eelgrass and cordgrass distribution (1997, 1998, & 1999)**

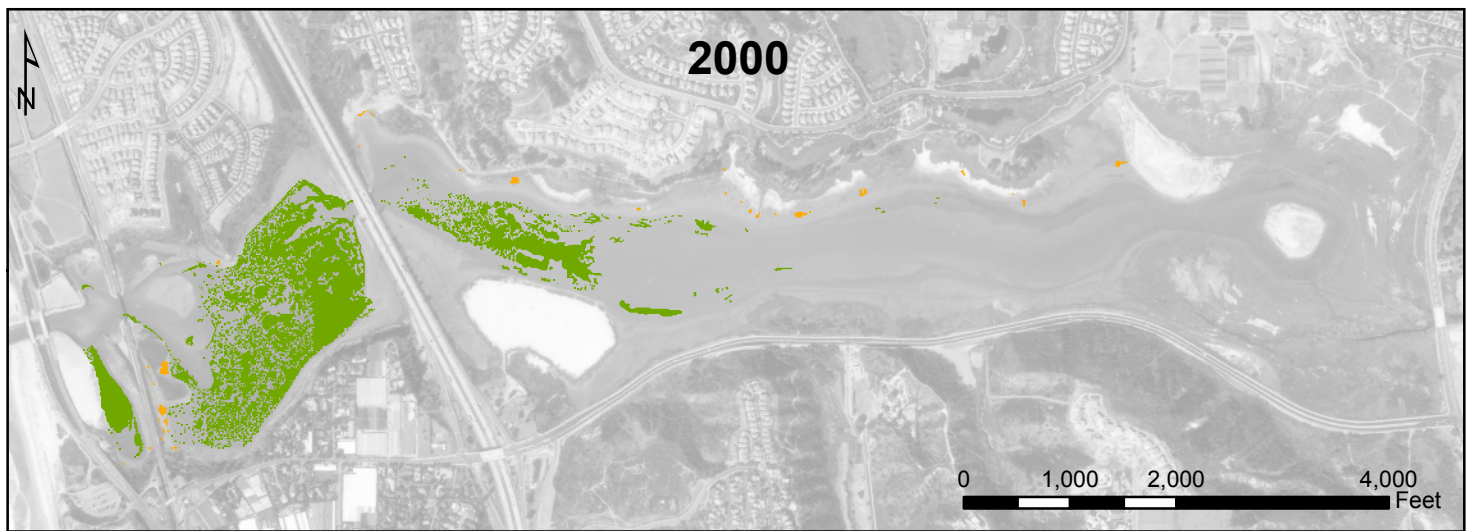
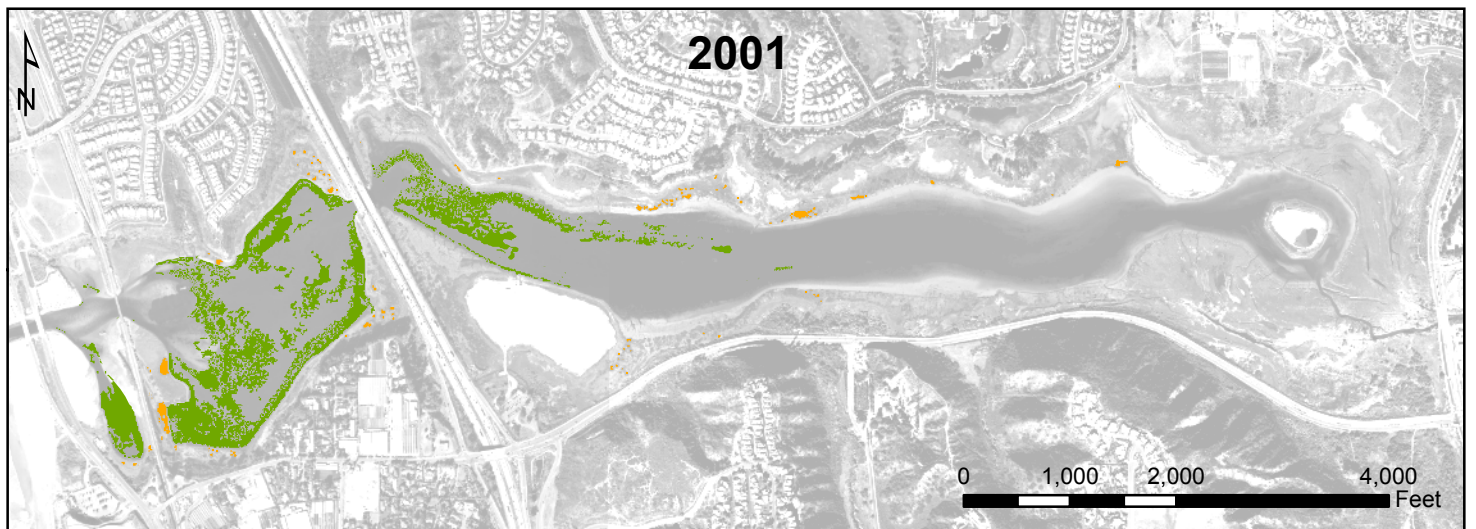
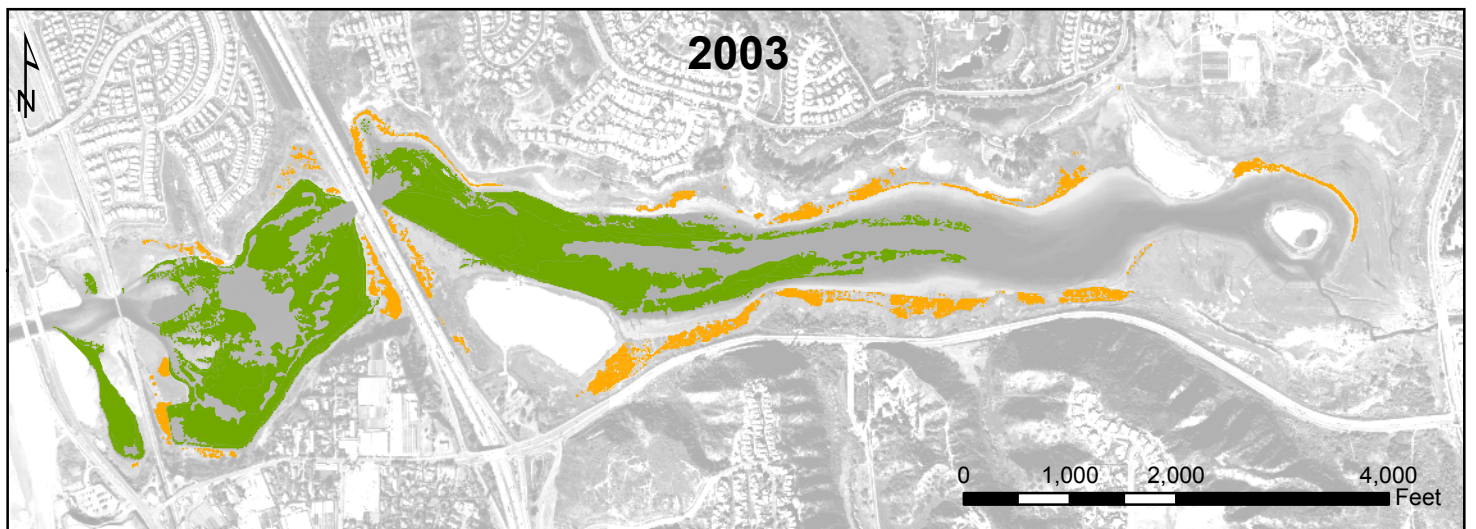
**Figure 4-3b**

**Pilot revegetation program  
eelgrass and cordgrass distribution (2000, 2001, & 2003)**

Cordgrass was not monitored in year 5 (2002). By year 6 (2003), however, cordgrass had rapidly expanded to cover 24.61 acres (Figure 4-3b). This was more than a 10-fold expansion from 2001. By year 9 (2005), cordgrass had further expanded to fill most of the available habitat around the lagoon and totaled 47.60 acres. In 2006, cordgrass expanded slightly to 52.93 acres (Figure 4-3c) and ranged between approximately +2.5 feet and +6.0 feet MLLW, with a mean elevation of approximately +3.7 feet MLLW. The expansion of cordgrass came at the expense of open mudflat, which was greatly reduced in acreage as cordgrass reached its maximum extent (see Chapter 3).

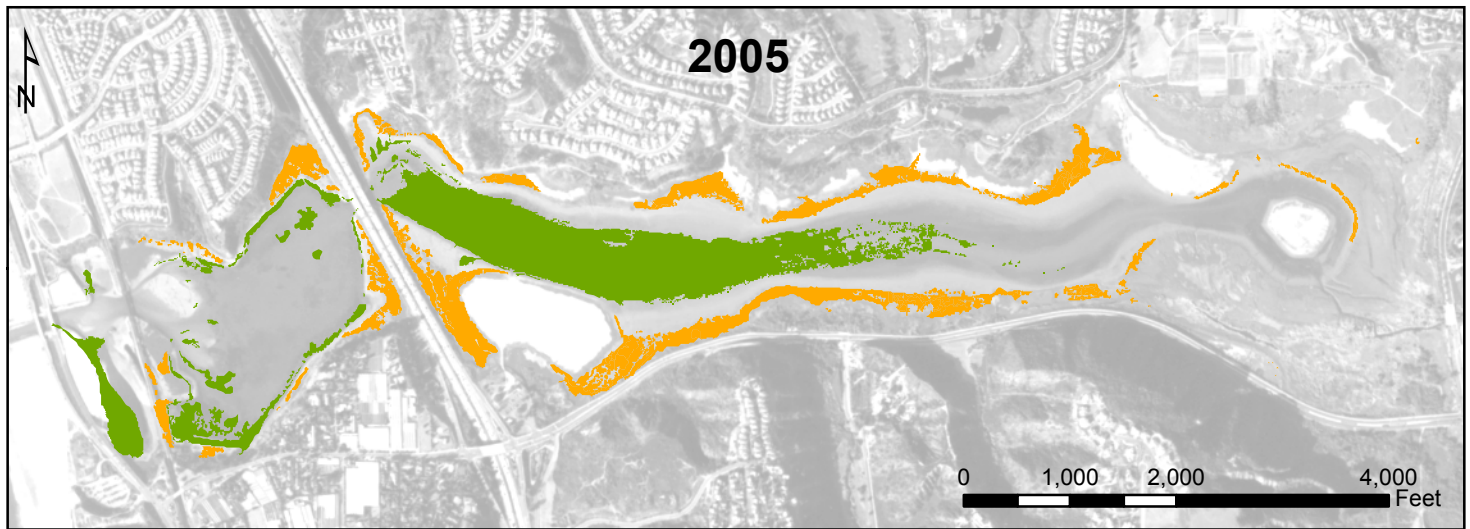
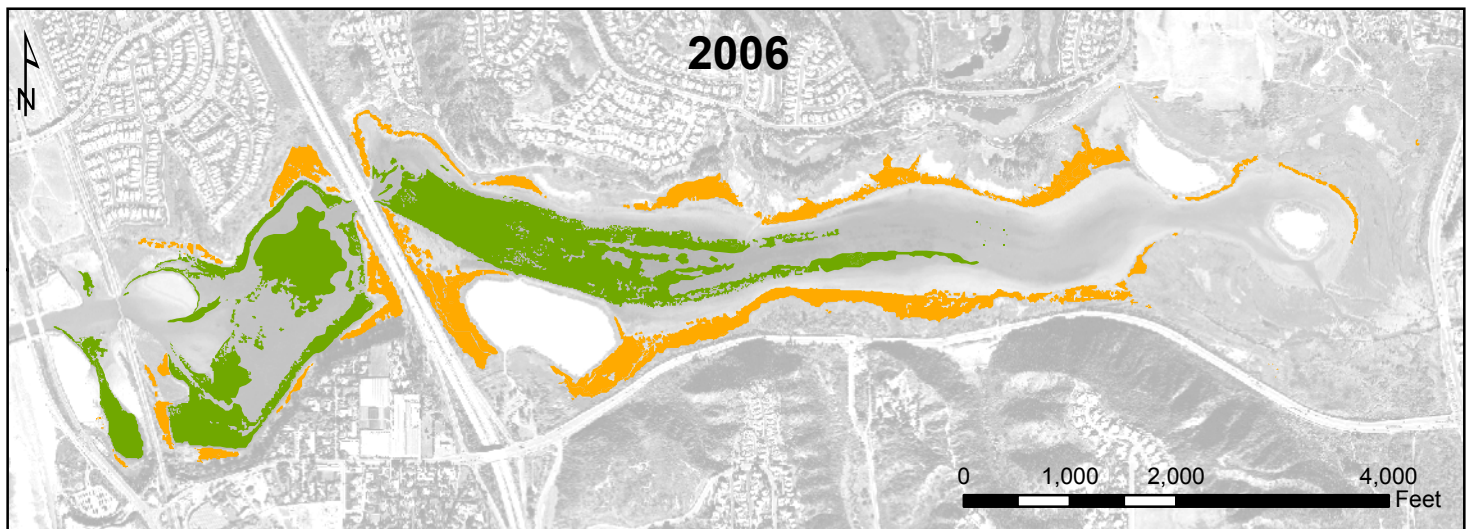
**Figure 4-3c**

**Pilot revegetation program  
eelgrass and cordgrass distribution (2005 & 2006)**

In the east basin, eelgrass occupies most of the subtidal habitat within the western half of the east basin. Heading east, eelgrass begins to be restricted to the slightly deeper central channel, as the mudflats are too shallow to support eelgrass. Further east, eelgrass ceases to exist altogether. Although the depth of the central channel in the eastern half of the lagoon is sufficient for eelgrass, turbidity likely prevents eelgrass growth. In this portion of the lagoon, wind-driven waves likely cause suspension of fine sediments from the adjacent mudflats. The suspended sediments limit light availability to eelgrass as it is attenuated through the water column. The particles can also directly prevent light absorption when they settle onto eelgrass blades. Under variable turbidity conditions, eelgrass expands and contracts within the deepest portions of the east basin, often leaving narrow fringing beds between the upper desiccation limited tide range and the deeper, light limited depths (Figure 4-3).

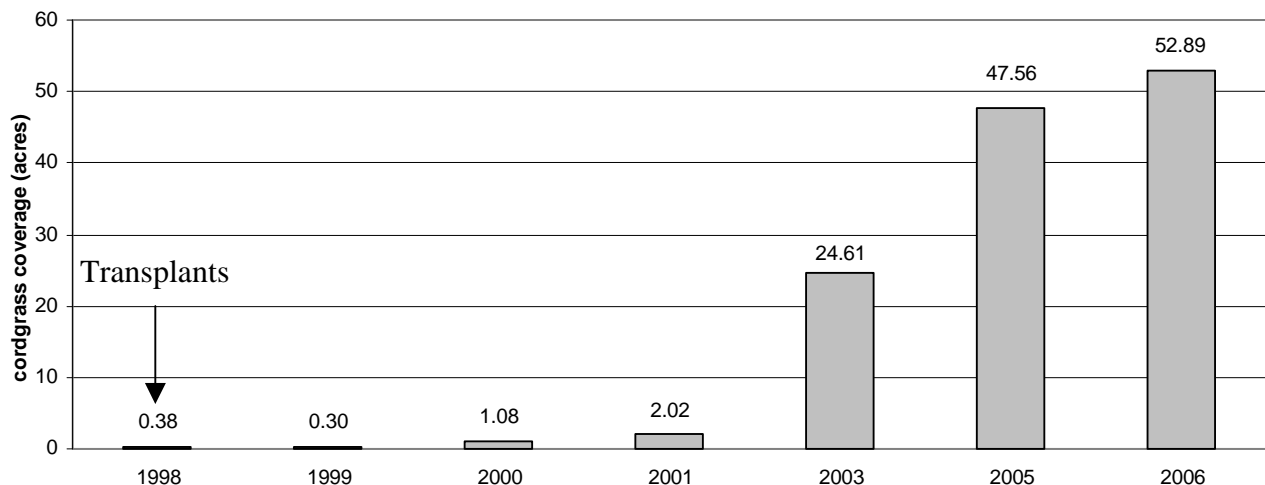
**Figure 4-4. Cordgrass coverage (1998-2006).**

Cordgrass expansion from the transplant sites was modest during the first four monitoring years, with the original 0.38 acre of transplanted cordgrass expanding to support 2.02 acres (Figure 4-4, Figure 4-3a, and Figure 4-3b). Initially, there was a slight loss in acreage, as some of the pilot transplanted areas at extreme elevations failed. In the transplant sites that supported cordgrass, however, it was in good health and observed as a mixture of dense stands or areas with sparse young shoots.

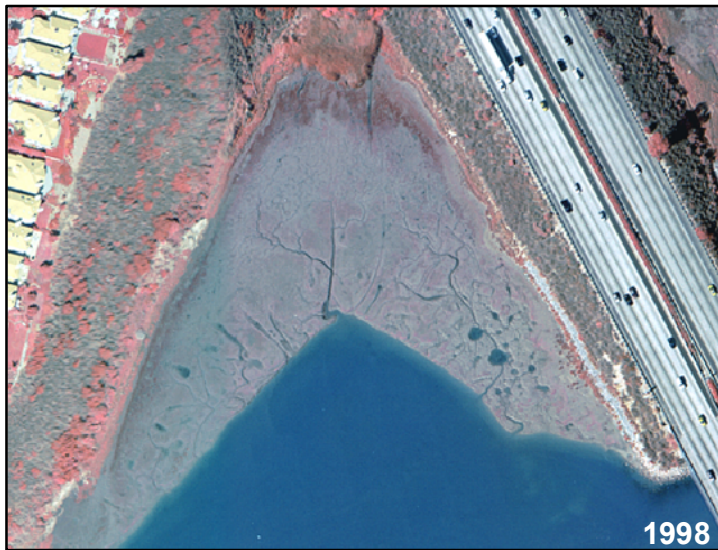
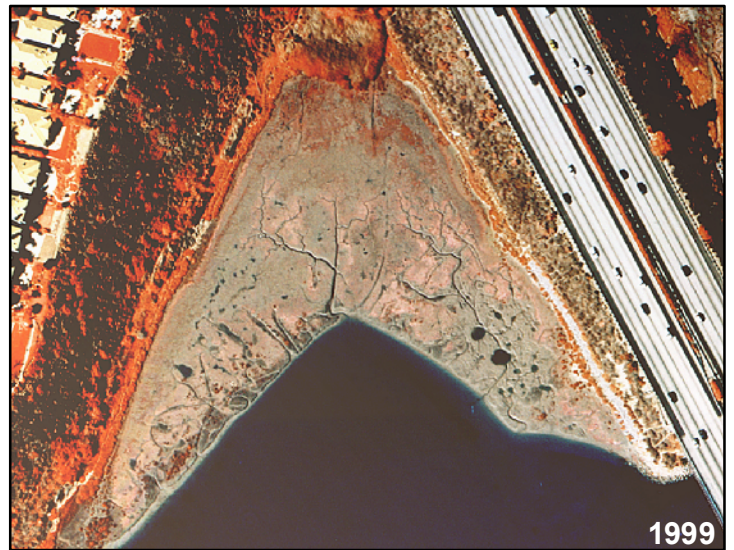
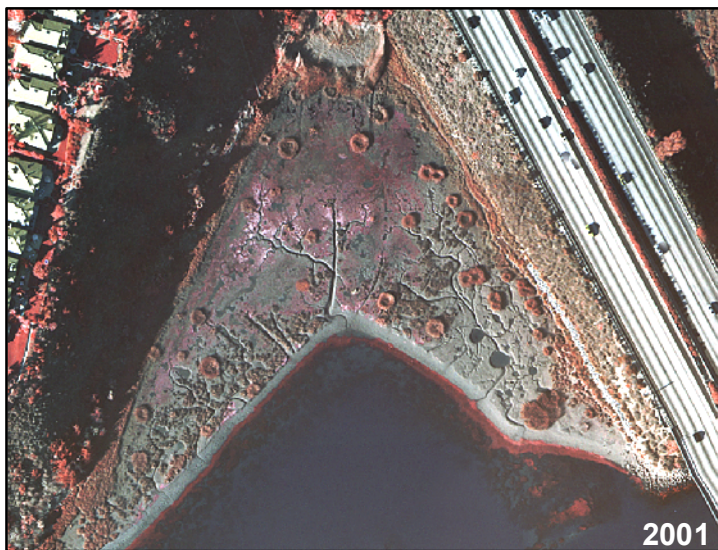
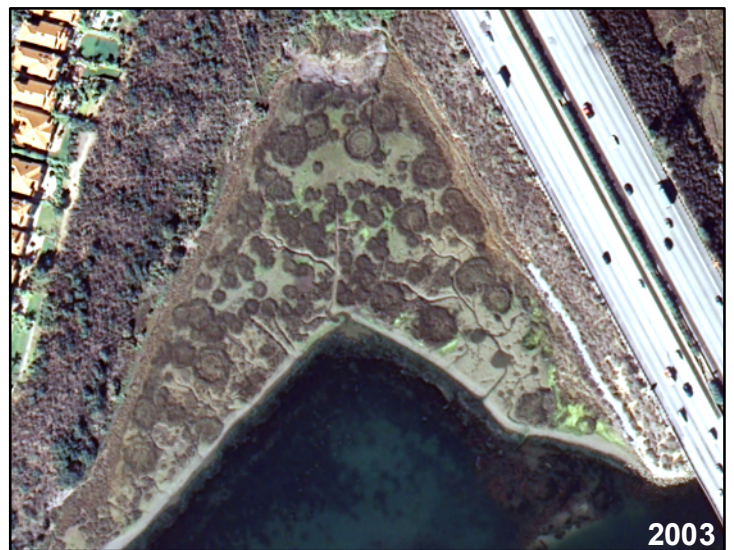
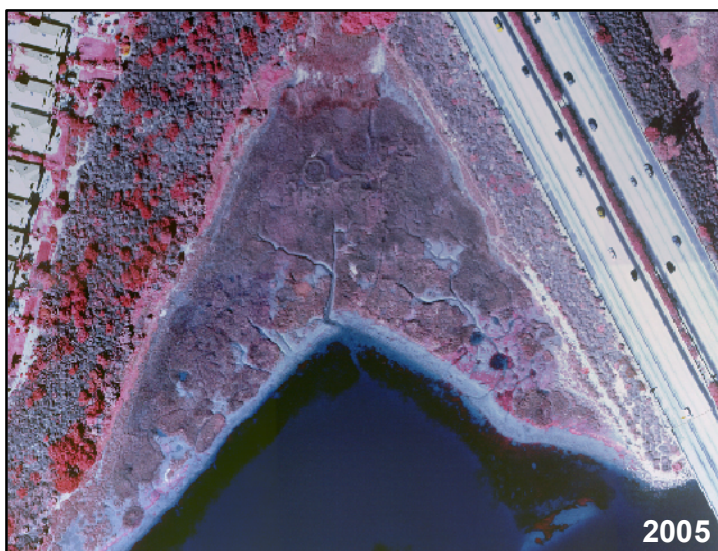
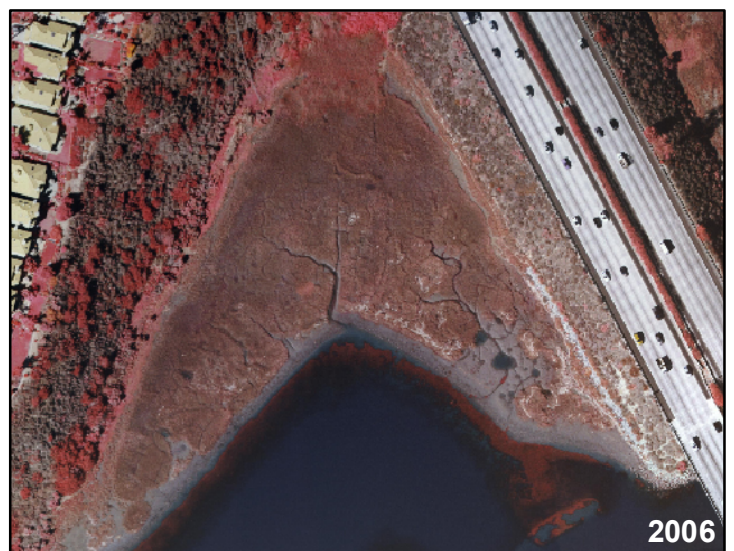
**Figure 4-5**

**Example of cordgrass  
expansion from seed**

Localized patterns of cordgrass growth were typical of clonal expansion following a transplant of individual shoot bundles. The observed patterns of growth well beyond the transplant sites indicate that the transplant sites provided seeds. The seeds floated (Huiskes et al. 1995) to, and germinated at, numerous nearby sites. Clonal growth then produced circular patch patterns as cordgrass grew to fill the open mudflat (Figure 4-5). Cordgrass patches established by seedling recruitment near planting transect I expanded at an average rate of  $4.69 \pm 1.11$  feet/year (measured as patch radius expansion) between 2001 and 2003 to fill the open space between patches.

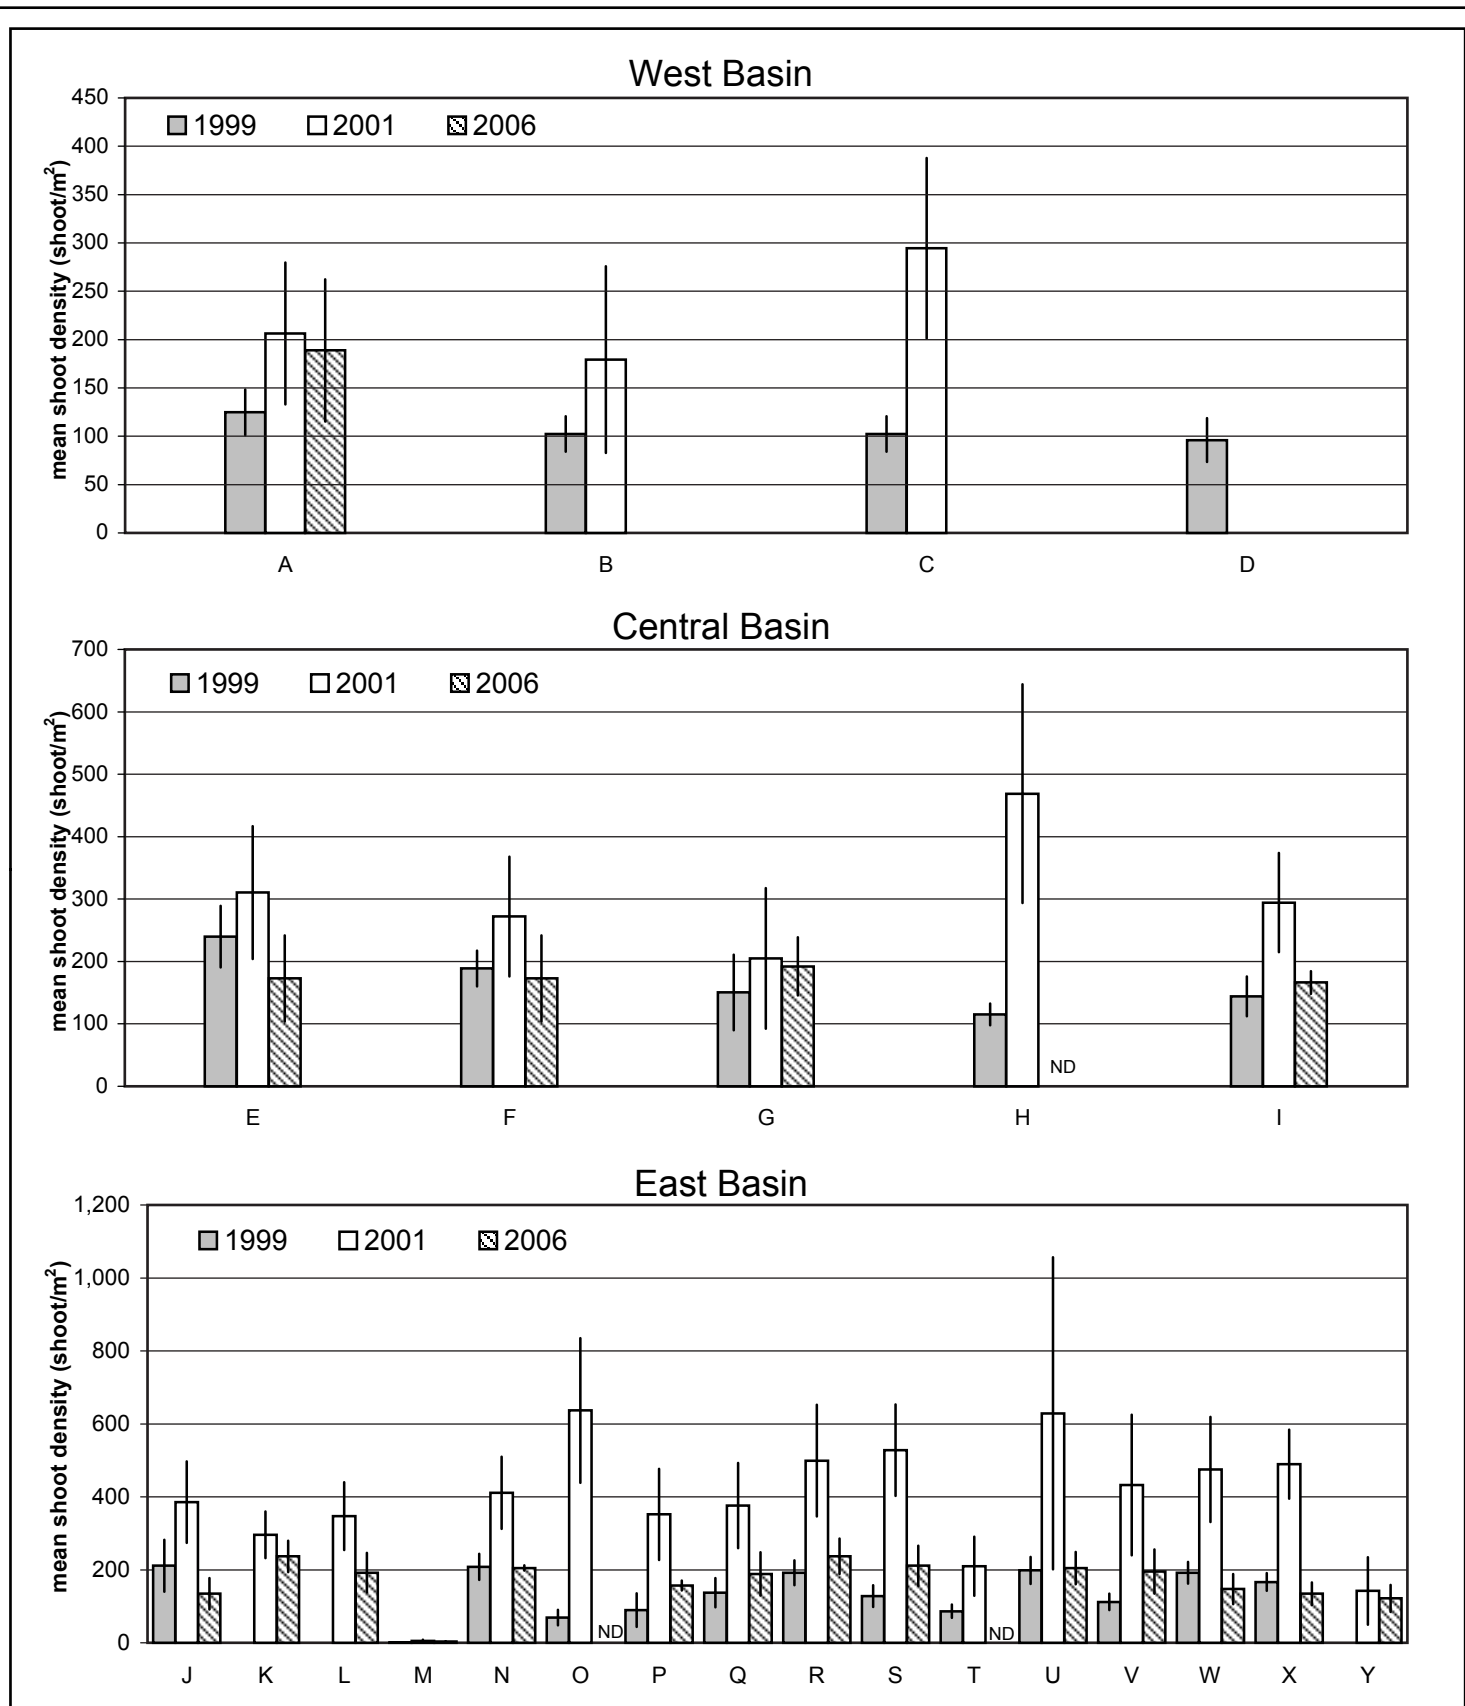
**Figure 4-6**

**Mean shoot density of cordgrass (*Spartina foliosa*) ( $\pm 1$  SD)  
within transplanted plots  
October 1999, September 2001, and October 2006**  
ND = no data, cordgrass present but original transplant not recoverable

Within the developing cordgrass stands, trends in shoot density were consistent across the monitoring sites. All sites that continuously supported cordgrass experienced increased density between the 1999 and 2001 monitoring events (Figure 4-6). By 2006, all sites where data were collected (in some cases transplant site boundaries were no longer identifiable), cordgrass density had declined from the densities observed in 2001 (Figure 4-6). In 1999, 2001, and 2006, the lagoon-wide cordgrass shoot densities (mean  $\pm$  1 SD) were  $122.2 \pm 80.1$ ,  $351.9 \pm 167.8$ ,  $155.3 \pm 80.8$  shoots/m<sup>2</sup>, respectively. These differences were statistically significant ( $p < 0.001$ ) with Tukey's HSD finding that the 1999 and 2006 monitoring events were similar, yet both different from 2001. There were no significant differences in density among basins ( $p = 0.61$ ). Mean density for all years combined was  $161.8 \pm 69.0$ ,  $220.9 \pm 91.8$ , and  $216.1 \pm 168.8$  shoots/m<sup>2</sup> for the west, central, and east basins, respectively.

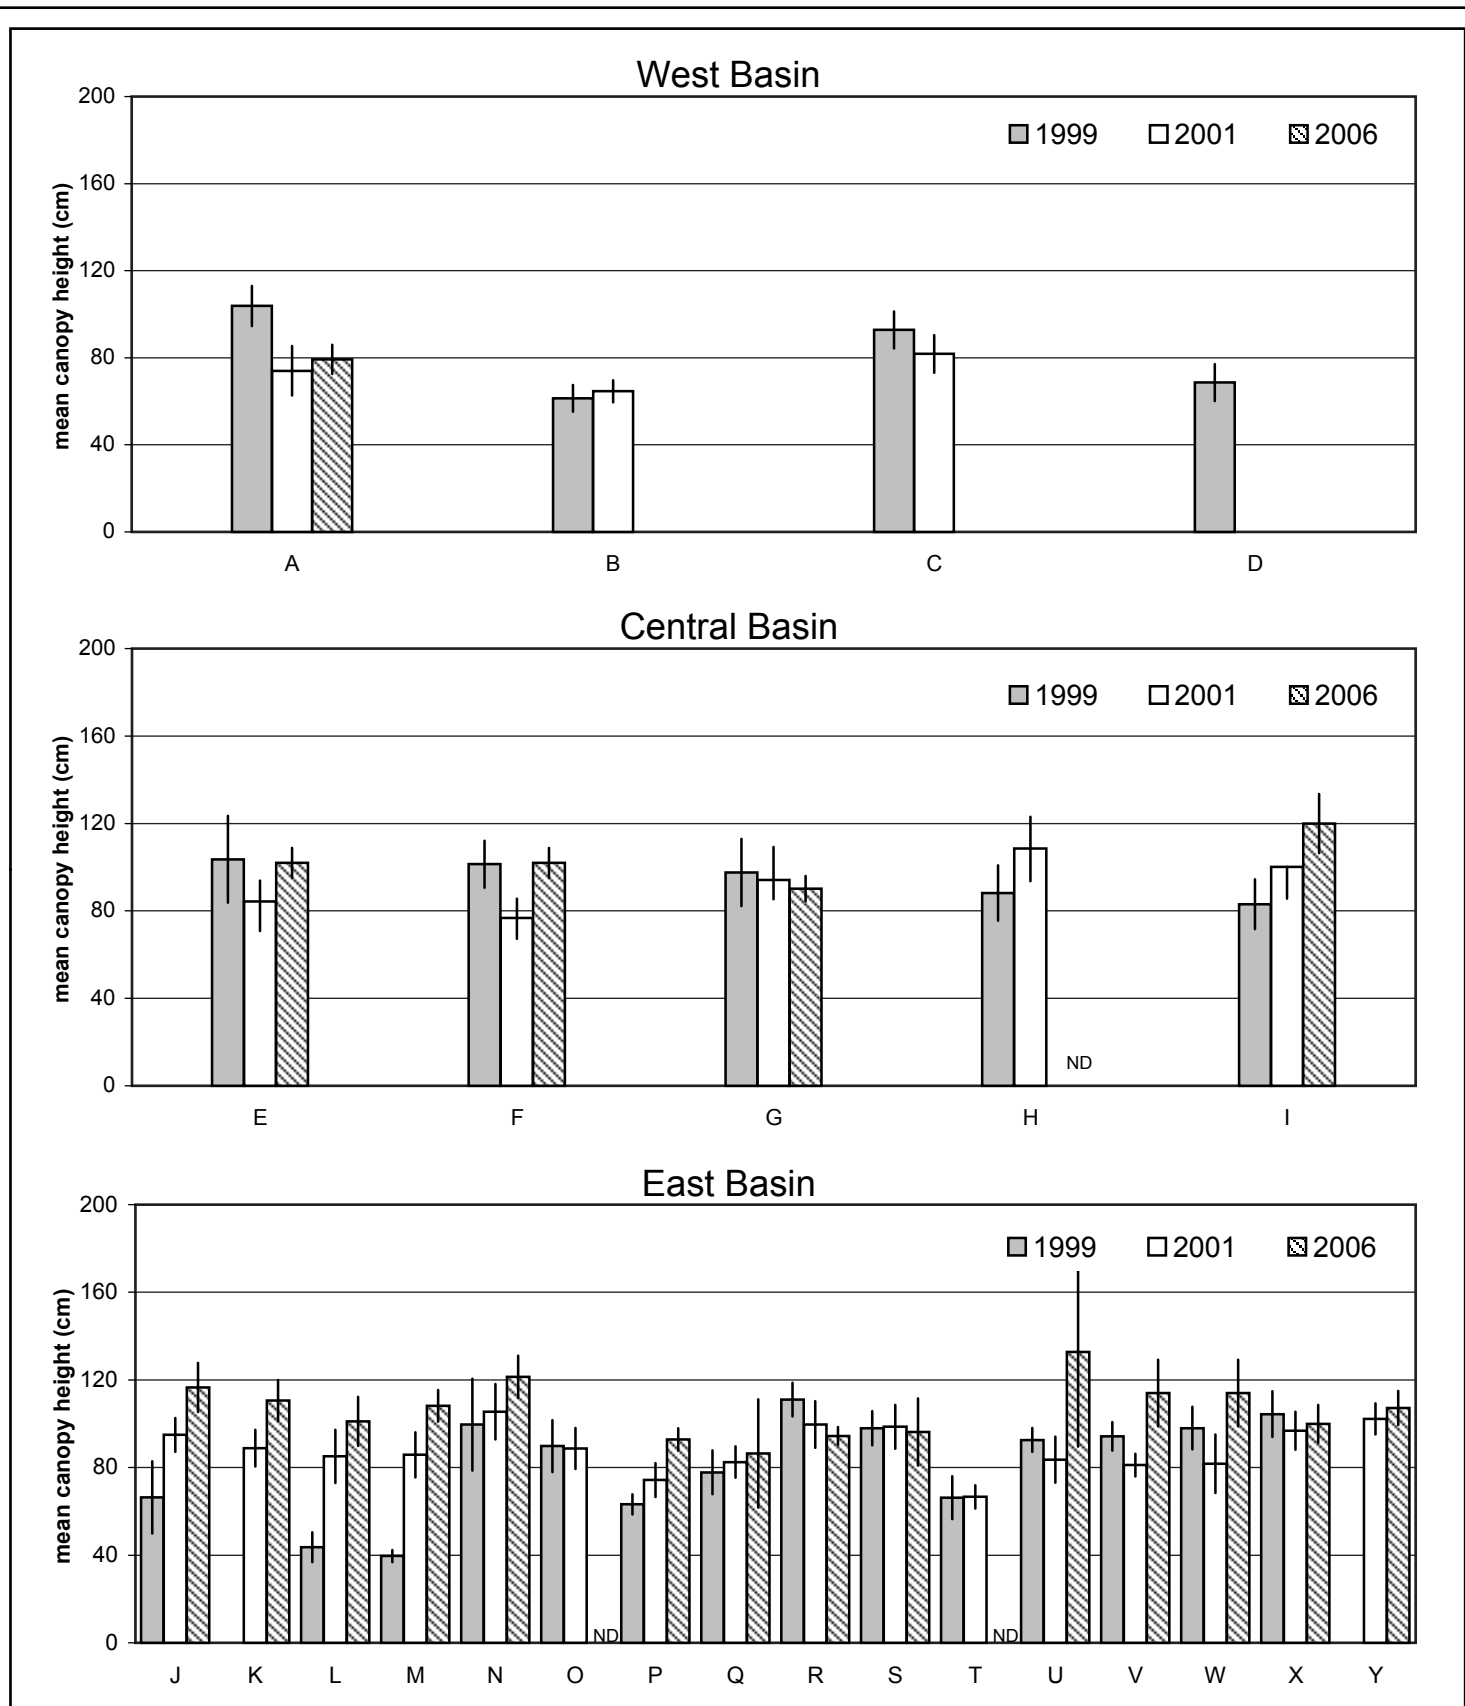
**Figure 4-7**

**Mean canopy height of cordgrass (*Spartina foliosa*) ( $\pm 1$  SD)  
within transplanted plots  
October 1999, September 2001, and October 2006**  
ND = no data, cordgrass present but original transplant not recoverable

Average canopy height (mean  $\pm$  1 SD) varied from a low of  $43.6 \pm 6.8$  cm at east basin transect L in 1999 to a high of  $132.8 \pm 43.2$  cm at east basin transect U in 2006 (Figure 4-7). Generally, cordgrass canopy height ranged from between approximately 80 and 120 cm. The overall average canopy height was  $88.7 \pm 23.3$  cm. Cordgrass canopy height increased lagoon-wide

over the three monitoring periods from  $77.8 \pm 30.2$  to  $87.5 \pm 11.8$  and  $104.7 \pm 13.4$  cm, for 1999, 2001, and 2006, respectively. This trend was statistically significant ( $p < 0.001$ ) with Tukey's HSD multiple comparisons test finding that 1999 and 2001 monitoring events were similar, yet both different from 2006. There were no discernable trends among basins ( $p = 0.200$ ) with regard to canopy height. The west, central, and east basins had canopy heights of  $78.3 \pm 14.4$ ,  $96.6 \pm 11.4$ , and  $88.2 \pm 26.4$  cm, respectively.
